TRASHING THE SESPE

**How the Oil Industry is Littering Our
Public Lands and Endangering Wildlife**

November 2013

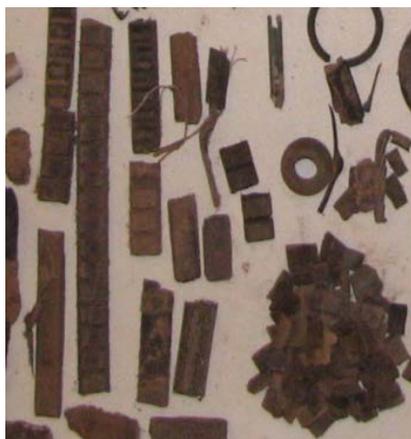
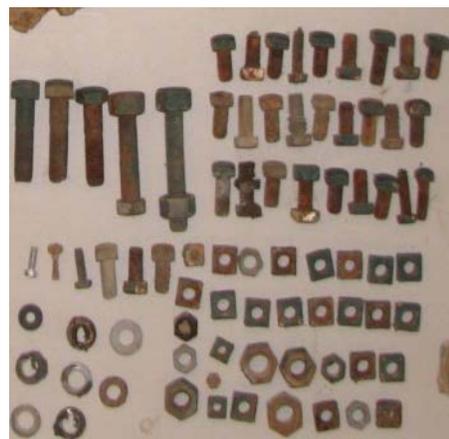
The most common items we discovered on the well pads were small pieces of deteriorated rubber belts that drive the oil well pumps. These rubber belts gradually weaken over time and, if not properly maintained, they disintegrate into dozens of tiny pieces that fall to the ground. While

they were not found on many pads (only three of the twelve pads), the pads where they were found had significant numbers of deteriorated rubber pieces surrounding the well pump.

7. Require employees and contractors to use non-lead solder to protect condors and other wildlife from lead poisoning.
8. Regularly maintain and inspect belts on well pumps, and replace them before breakage occurs.

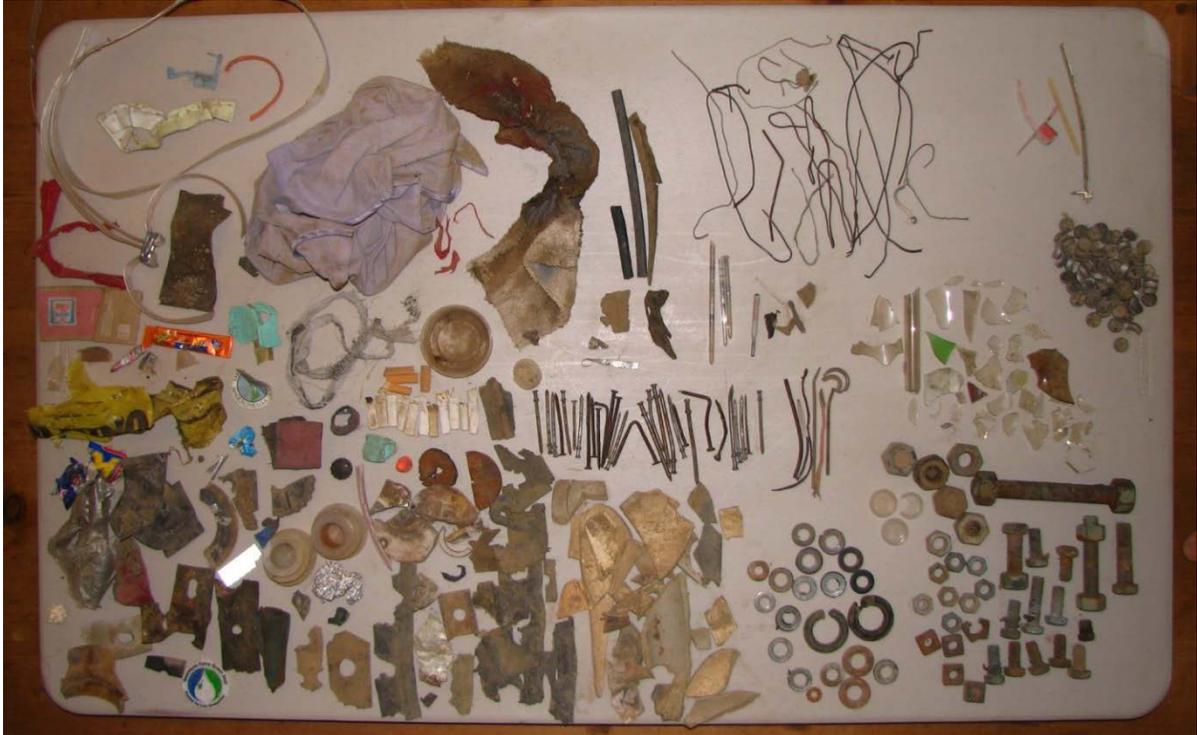
Orcutt Central Tank Battery (1st Visit): 325 pieces of microtrash totalling more than 10 pounds.

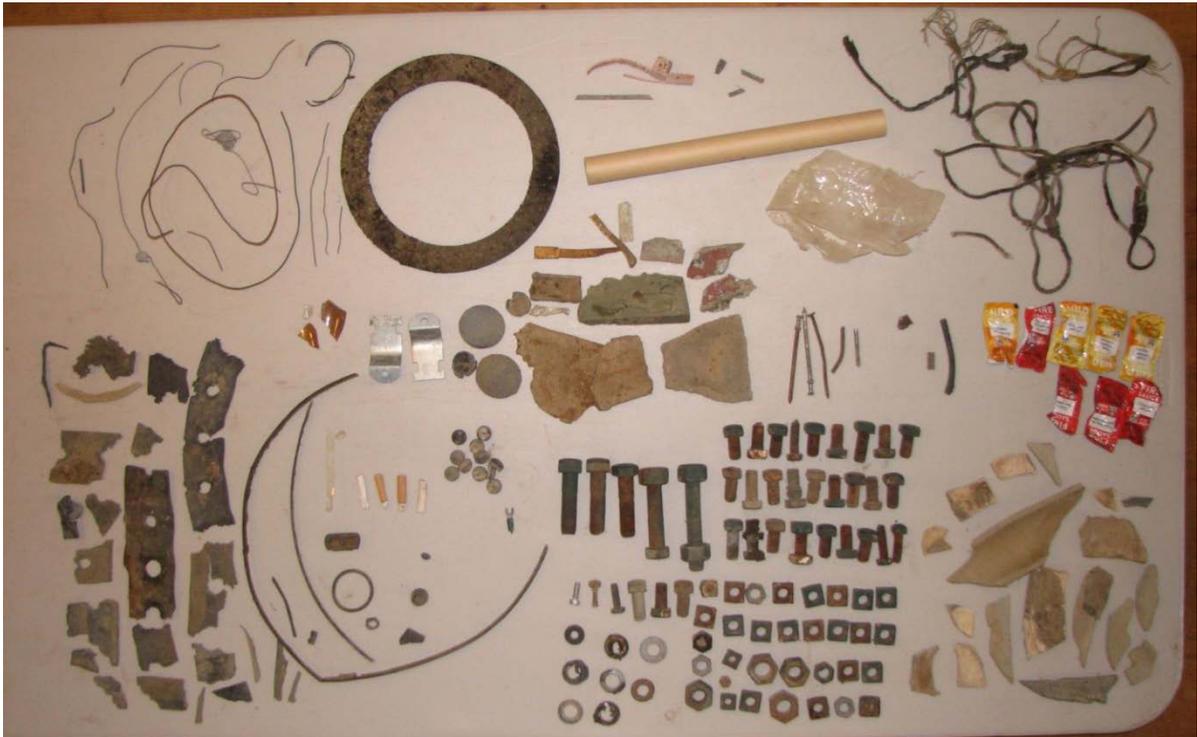
Orcutt Central Tank Battery (2nd Visit): 207 pieces of microtrash totalling more than 10 pounds.

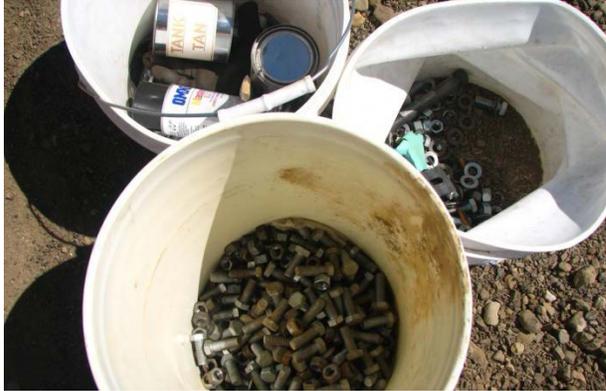
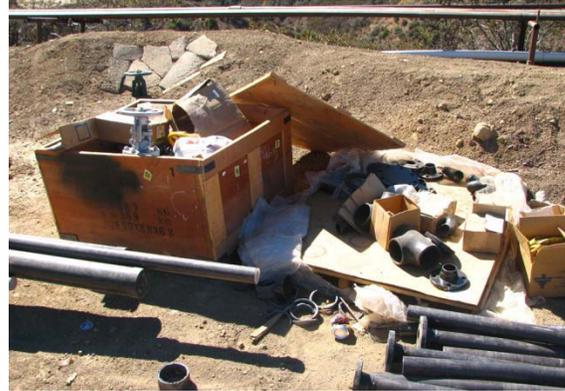
Uncovered Containers

Two of the pads we inspected were active work sites (though work was not occurring on the days we visited). On these pads, we observed several uncovered containers containing bolts, nuts, and other items within easy reach of condors. These pads also contained wood pallets with cardboard boxes, many of which were opened and contained small items. The boxes on the pallets were wrapped in thin plastic, which was decomposing from being exposed to the elements. This decomposing plastic presented another source of microtrash.

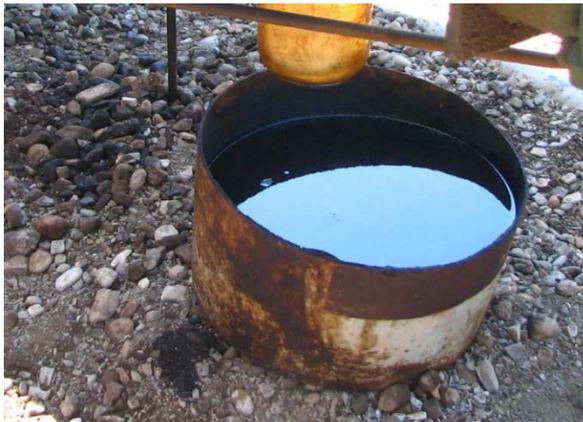
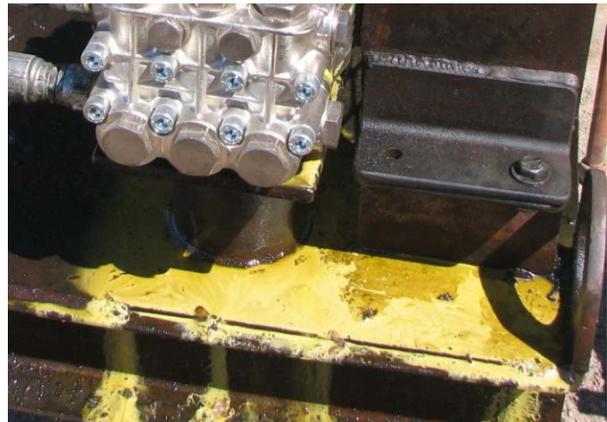
Hazardous Materials

In addition, we observed several open containers containing crude oil, chemicals, and other hazardous substances accessible by condors and other wildlife, along with leaking pipelines, tubes, tanks, well heads, and other equipment. Other hazards observed include segments of string, rope, hoses, cables, and wires that present a stangulation risk to condors. Finally, we observed eleven small pieces of melted solder at the Goodman Tank Battery and two other pads. Certain types of solder contain lead, which can be harmful or fatal to condors if ingested.

3. Properly cover all cables and hoses that present a strangulation hazard to condors.
4. Properly cover or remove open buckets of oil and other hazardous fluids.

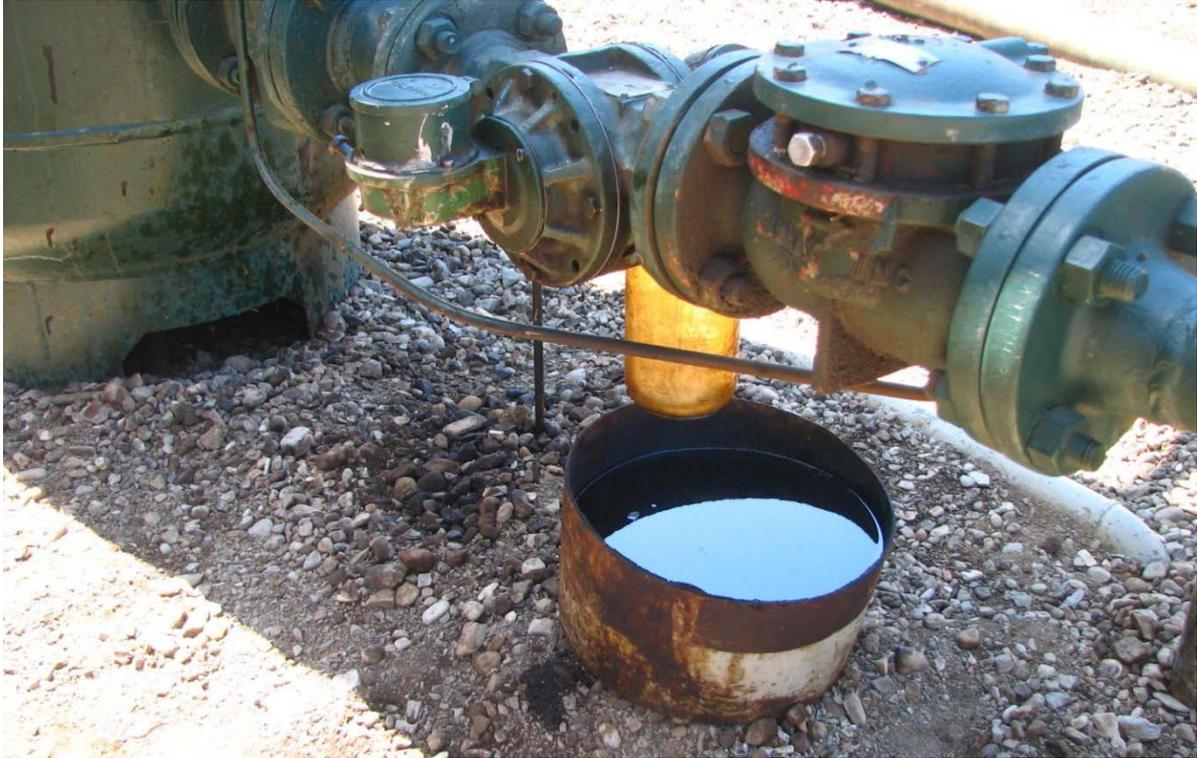
Crude oil is exposed in this open container accesible to condors and other wildlife.

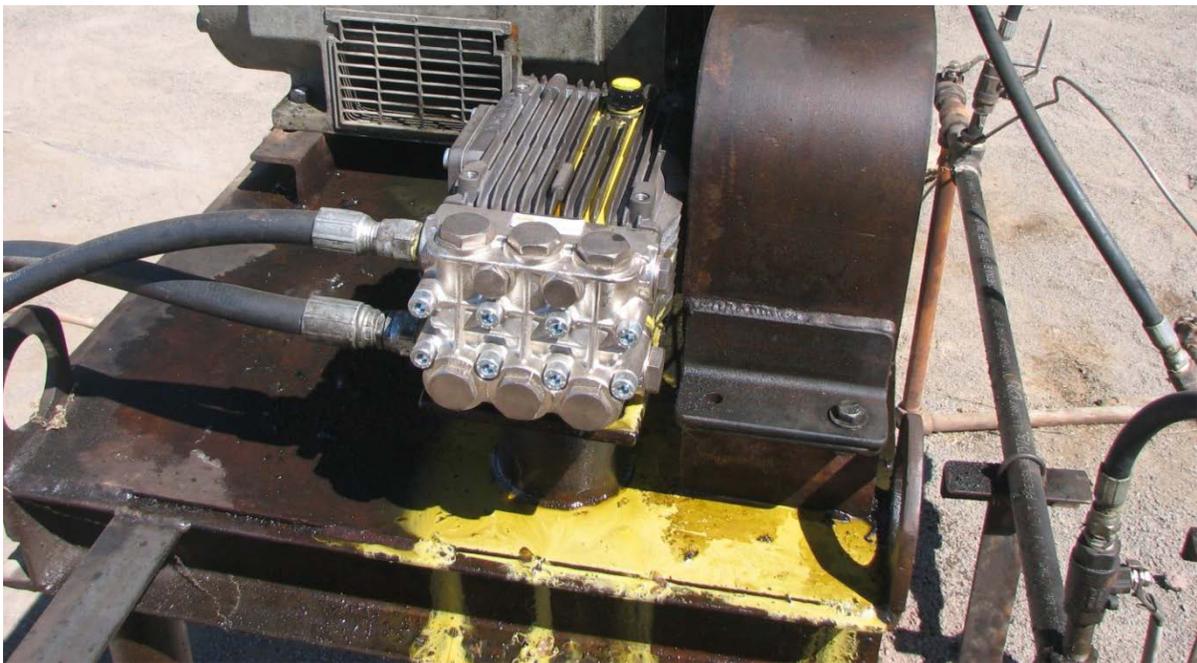
Unknown yellow fluid leaking from equipment and contaminating the soil below.

- d. Goodman Wells 1, 3 – unknown yellow fluid leaking from equipment
 - e. Shale Ridge Well 18-28 – oil leaking from wellhead
10. Remove the following items on the wellpads to prevent hazards to condors and other wildlife:

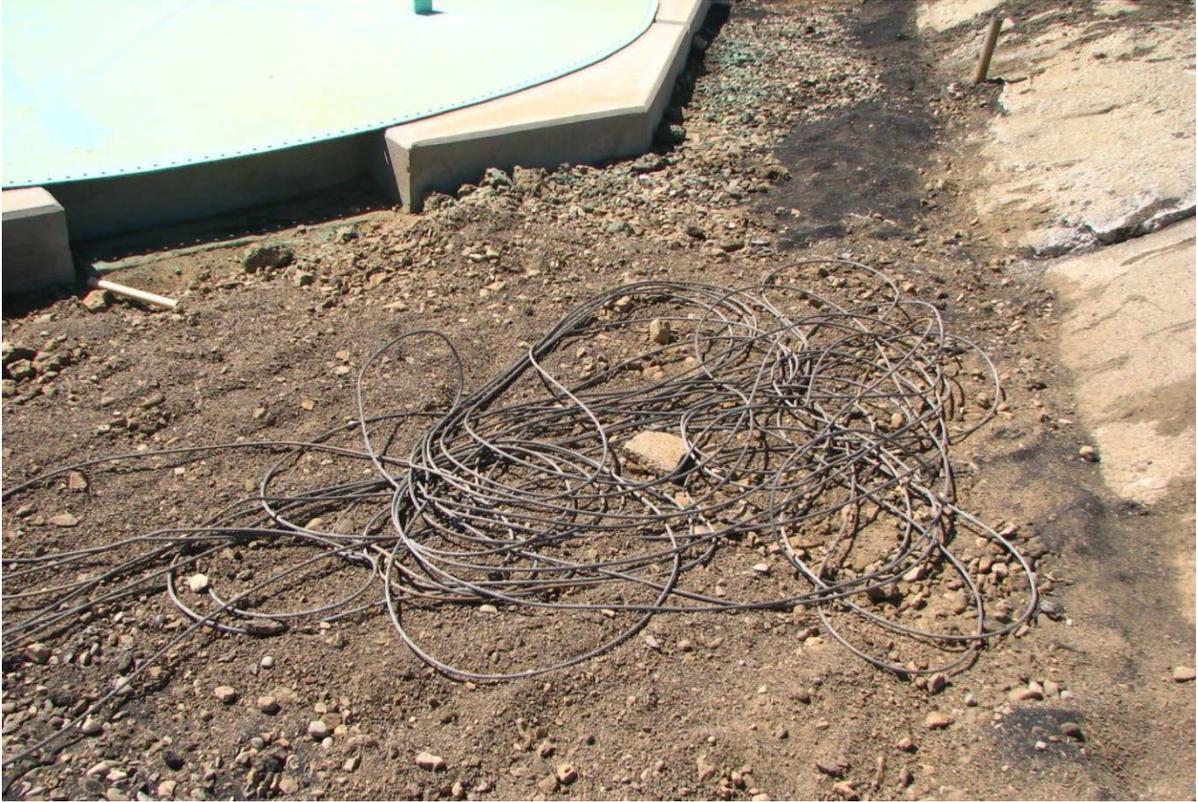
This coiled cable presents a strangulation hazard to condors.

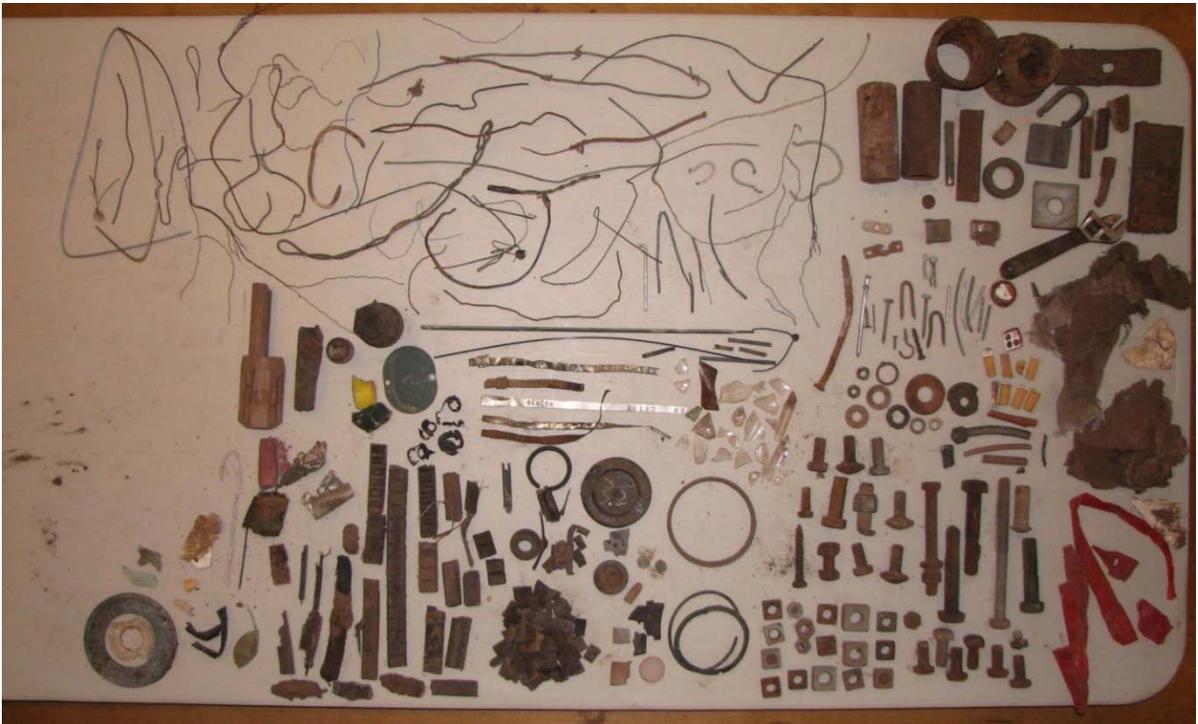
Bonebrake A Tank Battery: 372 pieces of microtrash totalling more than 16 pounds.

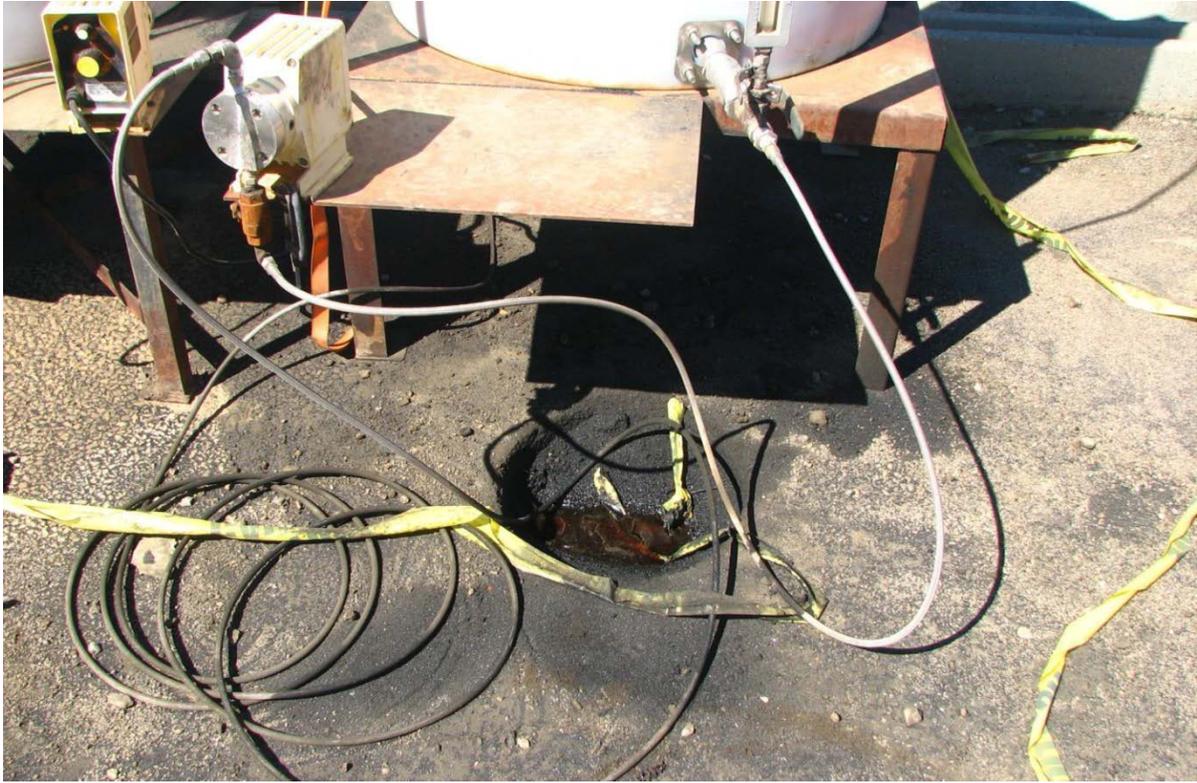
Leaking chemicals and strangulation hazard.

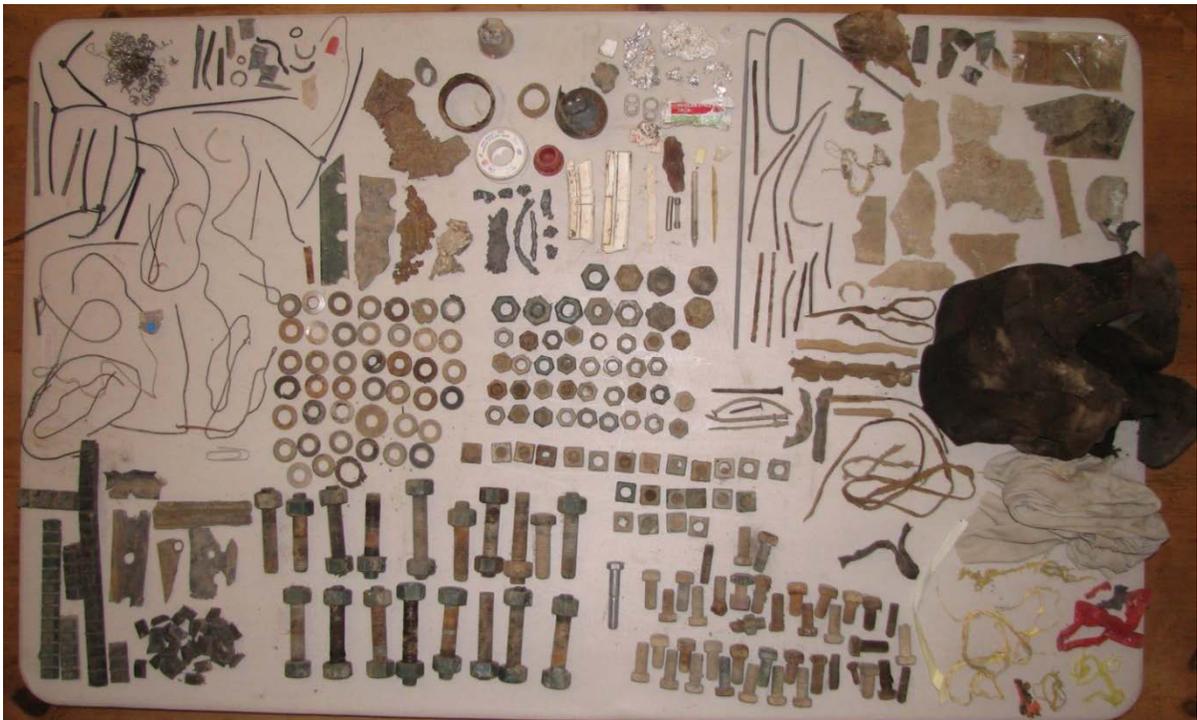
Goodman Tank Battery: 389 pieces of microtrash totalling more than 18 pounds.

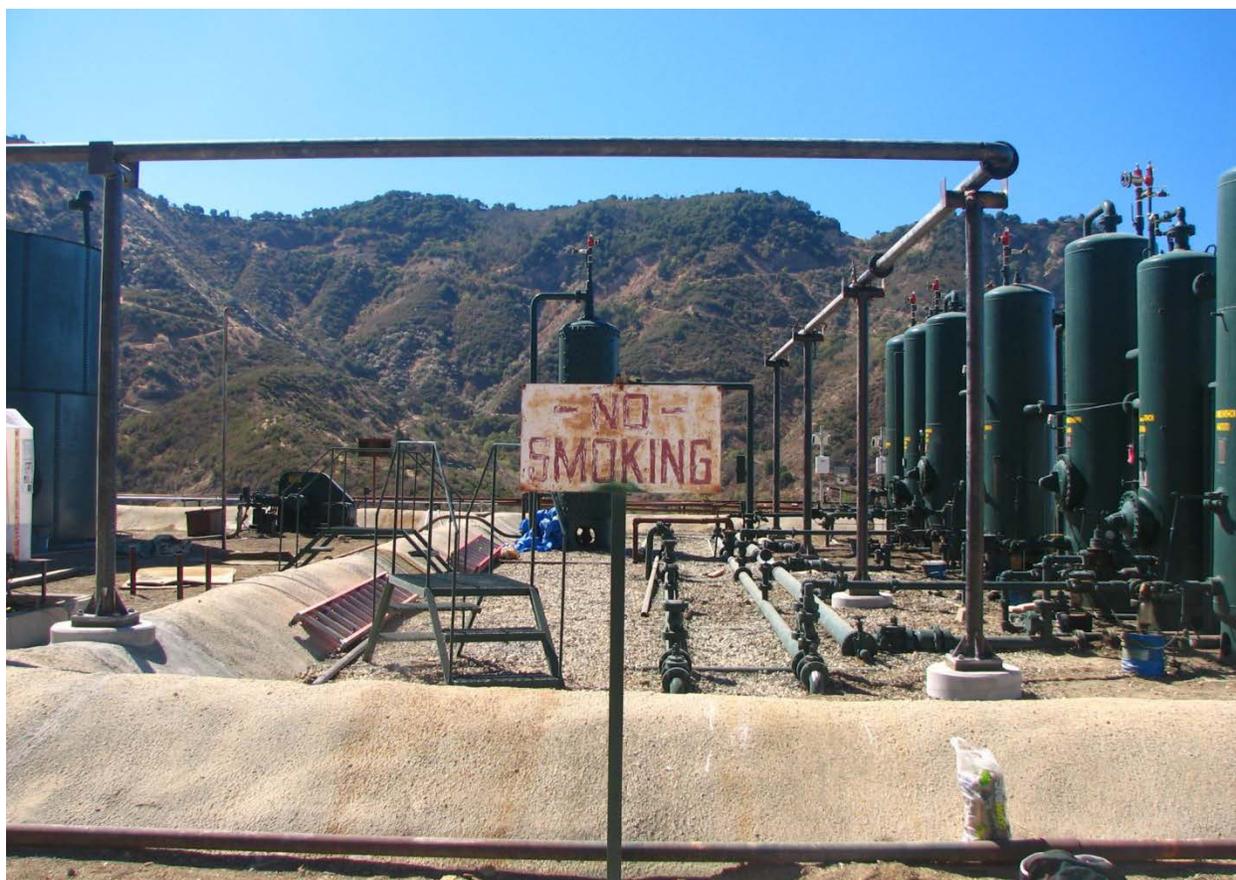
Orcutt Central Tank Battery

The Orcutt Tank Battery is located along a ridge above Maple Creek on land managed by the U.S. Forest Service. It includes a 1,000-barrel tank that is no longer in service, a concrete pad without a tank, two temporary rollaway tanks, two small plastic tanks filled with chemicals, and several pipelines and other equipment. The pad appeared to be an active work site, as we observed a tractor, a portable toilet, tarps, ladders, and a contractor's truck during our visit, though no workers were present. The pad contained several signs prohibiting smoking in the area.

We observed a wooden crate containing large and small parts that could present a microtrash hazard to California condors. In addition, a wooden pallet wrapped in plastic also serves as a hazard to condors. Both the crate and the pallet did not comply with the requirement to keep all construction equipment and debris in covered, closed containers.

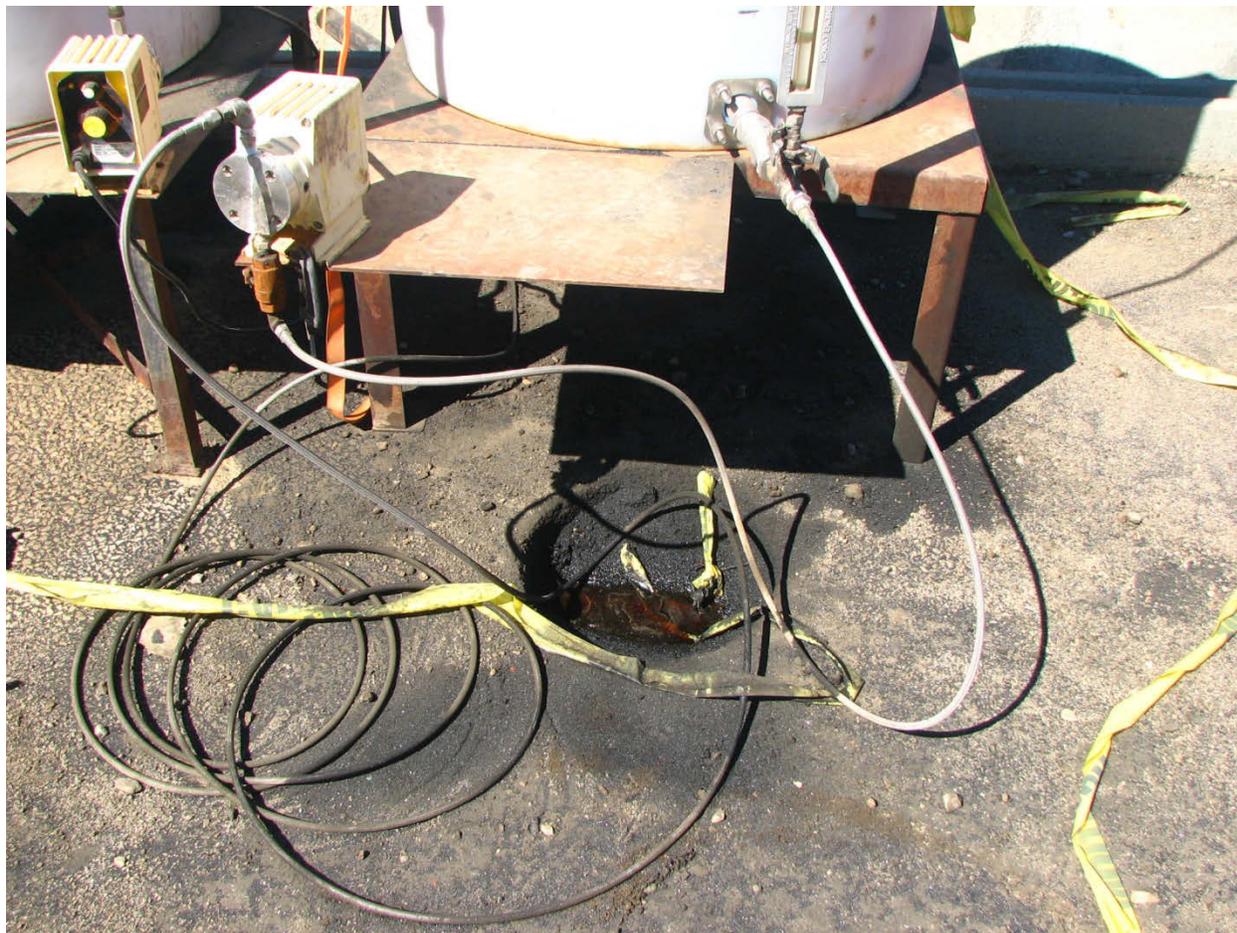
Two small plastic chemical tanks (labeled S31 Group Line and S32 Group Line) were located on the pad. One tank contained an emulsion breaker that is used to separate water and oil when they are pumped out of the ground together. The second tank contained an “iron sulfide control” to prevent iron sulfide buildup in equipment. We observed a pool of fluid underneath a leaking valve on the emulsion breaker tank that could pose a hazard to condors or other wildlife if ingested. This did not comply with the protective standards in place for condors.

In addition, we observed coiled hose and yellow caution tape beneath this tank, both of which present a strangulation hazard to condors. This did not comply with the requirement to cover all hoses with heavy mats to prevent access by condors.

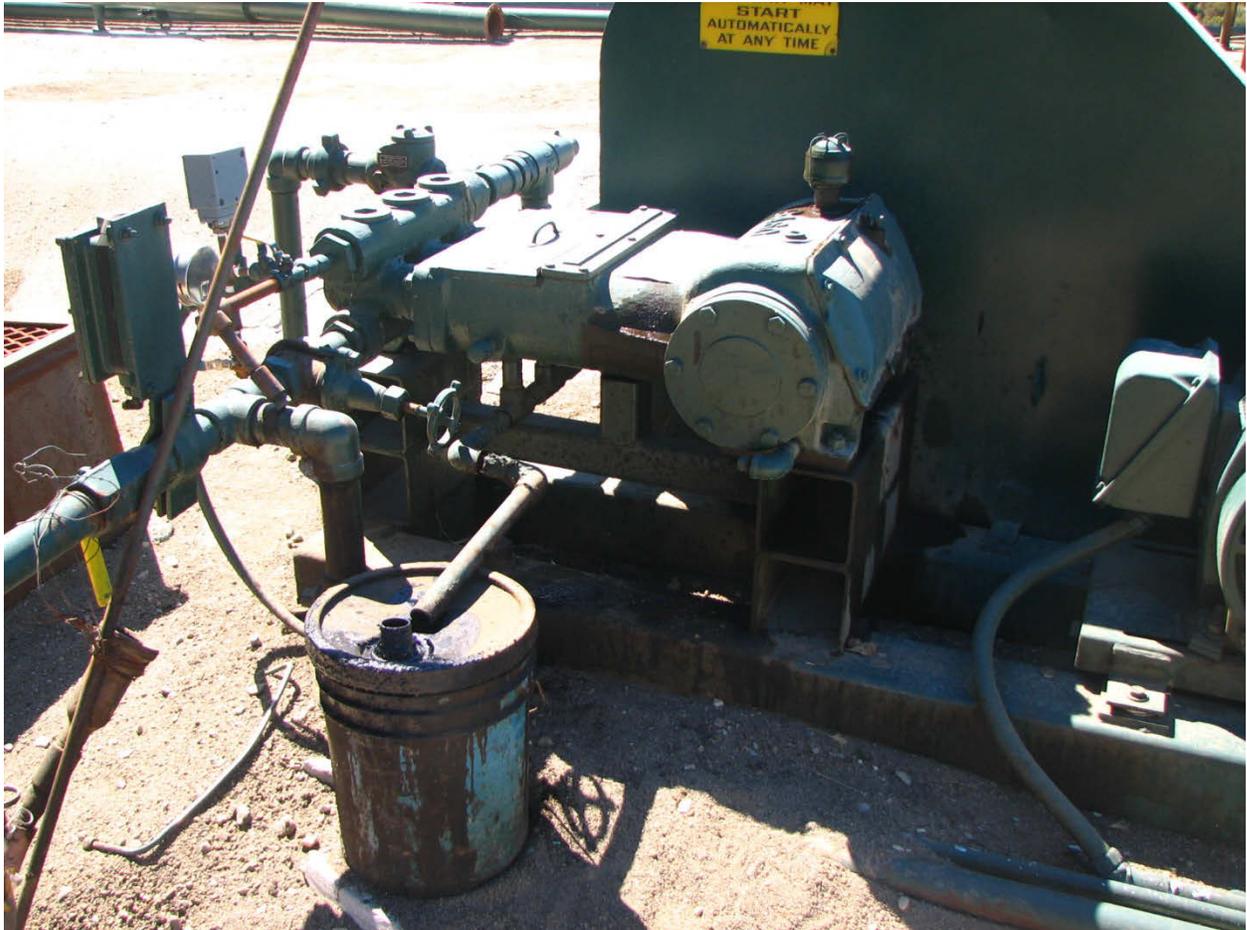
We observed small storage containers at this pad that were also leaking oil and presenting a hazard to condors and other wildlife. This container had pools of oil on the lid because the pipe was not properly connected to the hole in the lid.

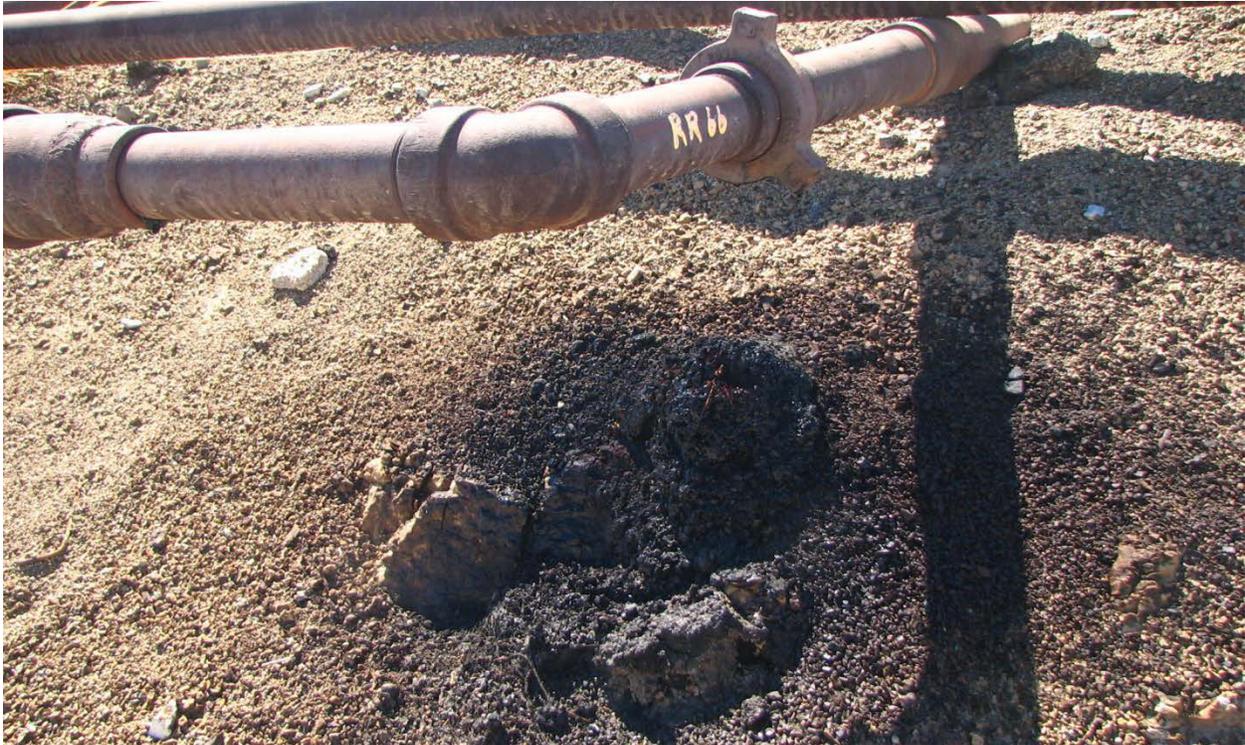
We observed a leaking pipe at this pad, contaminating the soil underneath. This contaminated soil could present a hazard to condors and other wildlife, and does not comply with the requirement to immediately clean up all hazardous fluids. In addition, we observed two large piles of dirt containing oil-soaked soil and large drops of oil that could contaminate condors or other wildlife.

- b. Pipeyard – oil leaking from utility pole
 - c. Orcutt Central Tank Battery – chemicals leaking from tubing, oil leaking from pipeline, and contaminated soil stockpiled

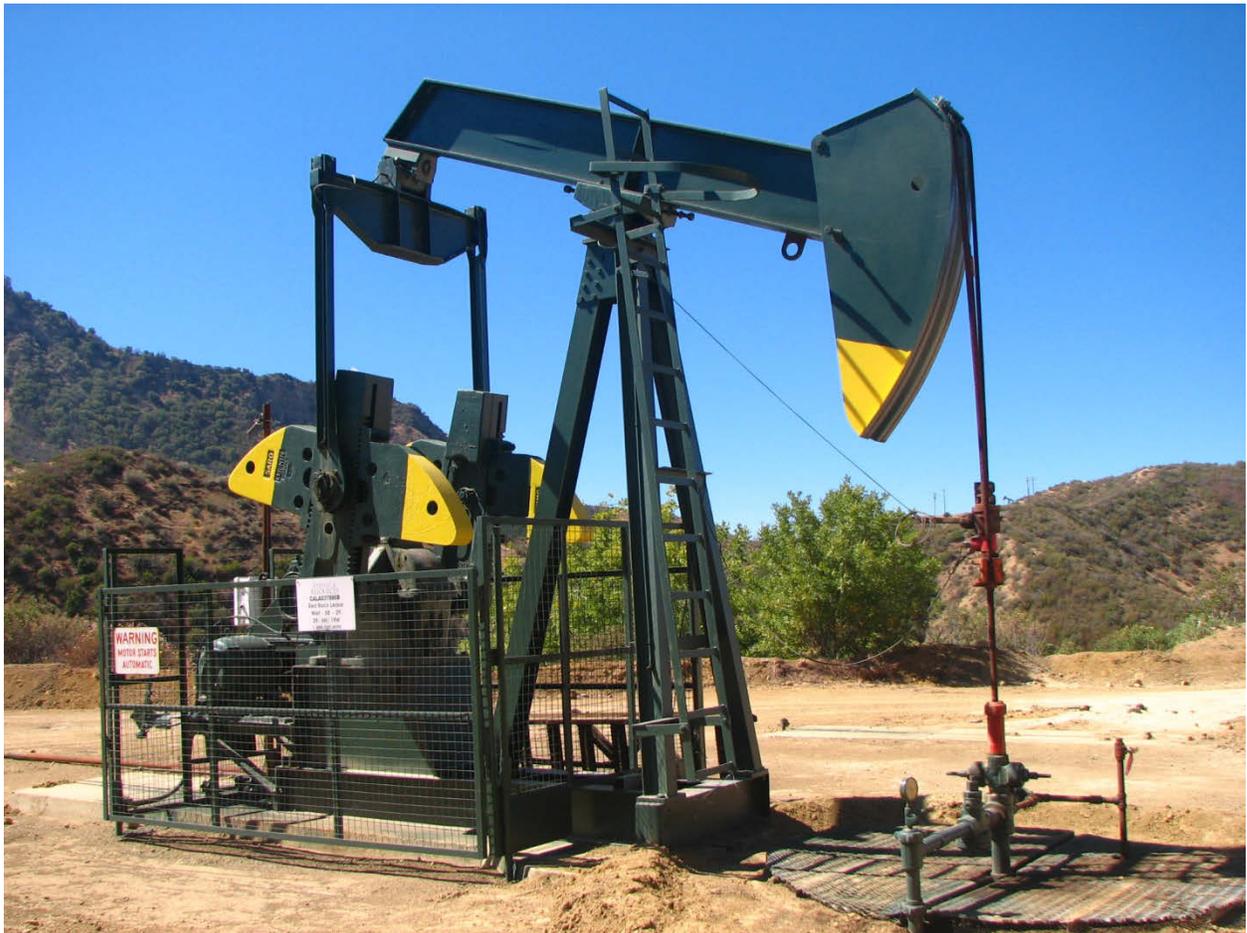
This pad is part of the Red Rock Lease, and contains one active oil well (Well 58-29), and two idle wells (Wells 67 and 68). The pad is located upslope of Maple Creek on national forest land.

We observed two plastic drums on the pad. They appeared to be empty, but were labeled as containing a corrosion inhibitor. We recommend that these drums be removed and properly disposed of, to eliminate any future risk of residual fluid leaks.

- e. Orcutt Central Tank Battery – remove rag containing nuts and bolts
 - f. Red Rock Well 58-29, 67, and 68 – remove empty chemical drums
11. Grant independent nonprofit organizations reasonable access to pads on private lands in the Sespe Oil Field, as well as those lands in and surrounding the Sespe Oil Field that are administered by the U.S. Fish & Wildlife Service as part of the national wildlife refuge system. Such access is necessary to ensure future compliance with these recommendations and other best management practices to protect condors and other wildlife.

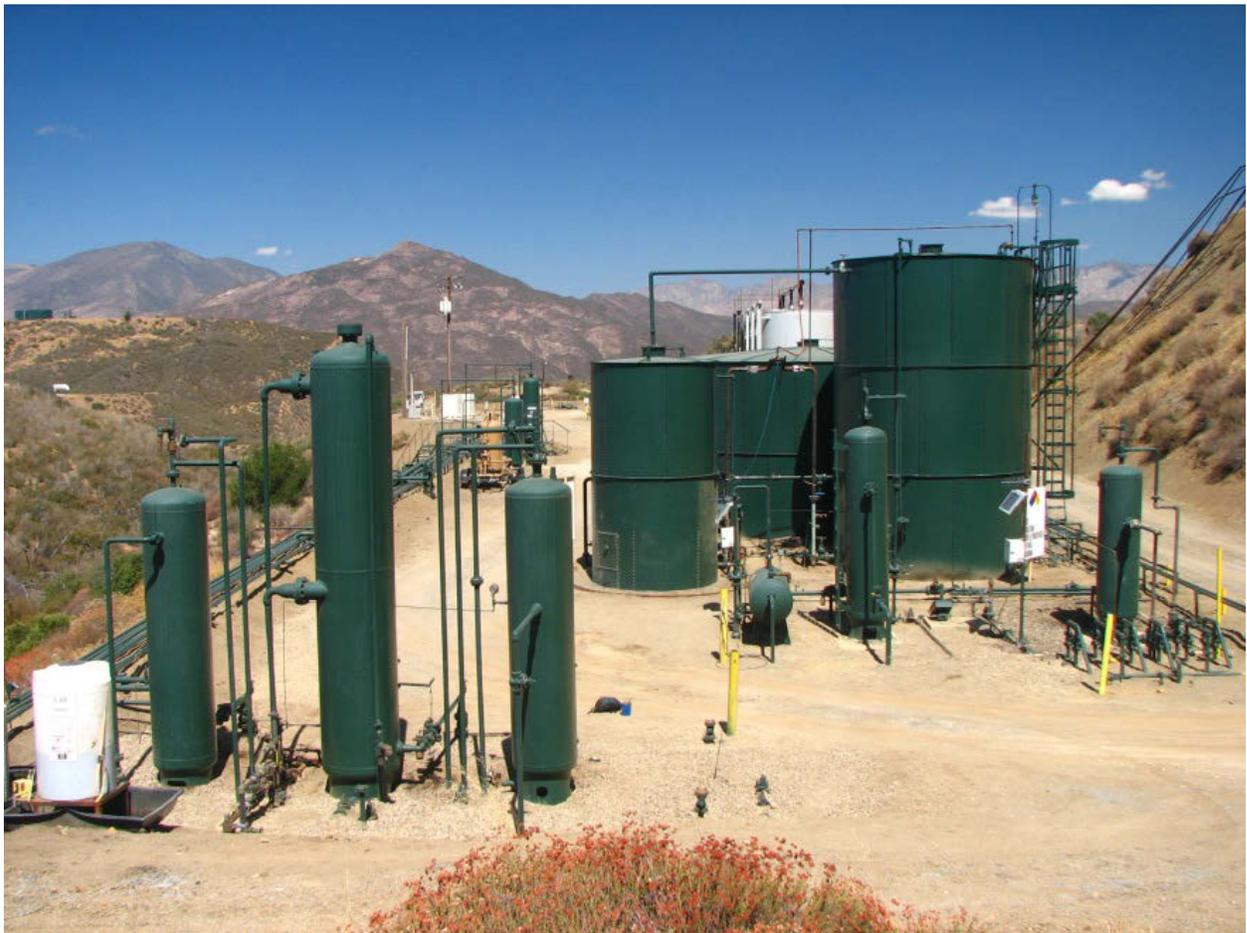
The Goodman Tank Battery consists of several large storage tanks on a large pad, including three 400-barrel tanks containing crude oil and produced water, a 1,000-barrel crude oil tank (S19), a 2,000-barrel blowdown tank (S21), and several other tanks containing crude oil. Several pipelines cross the pad, which also features two small plastic chemical tanks and various other infrastructure and equipment. Two active oil and gas wells (Goodman Wells 2 & 5) also occur on the pad, along with a portable toilet.

We observed two wooden pallets containing several large items and boxes of smaller items, including bolts, nuts, and small metal pipe fittings that could pose a microtrash hazard to condors. In addition, the pallets were loosely wrapped in a thin sheet of plastic that was visibly shredded in several places. A loose rag was also observed in this area, and an oiled loose rag was found elsewhere on the pad.

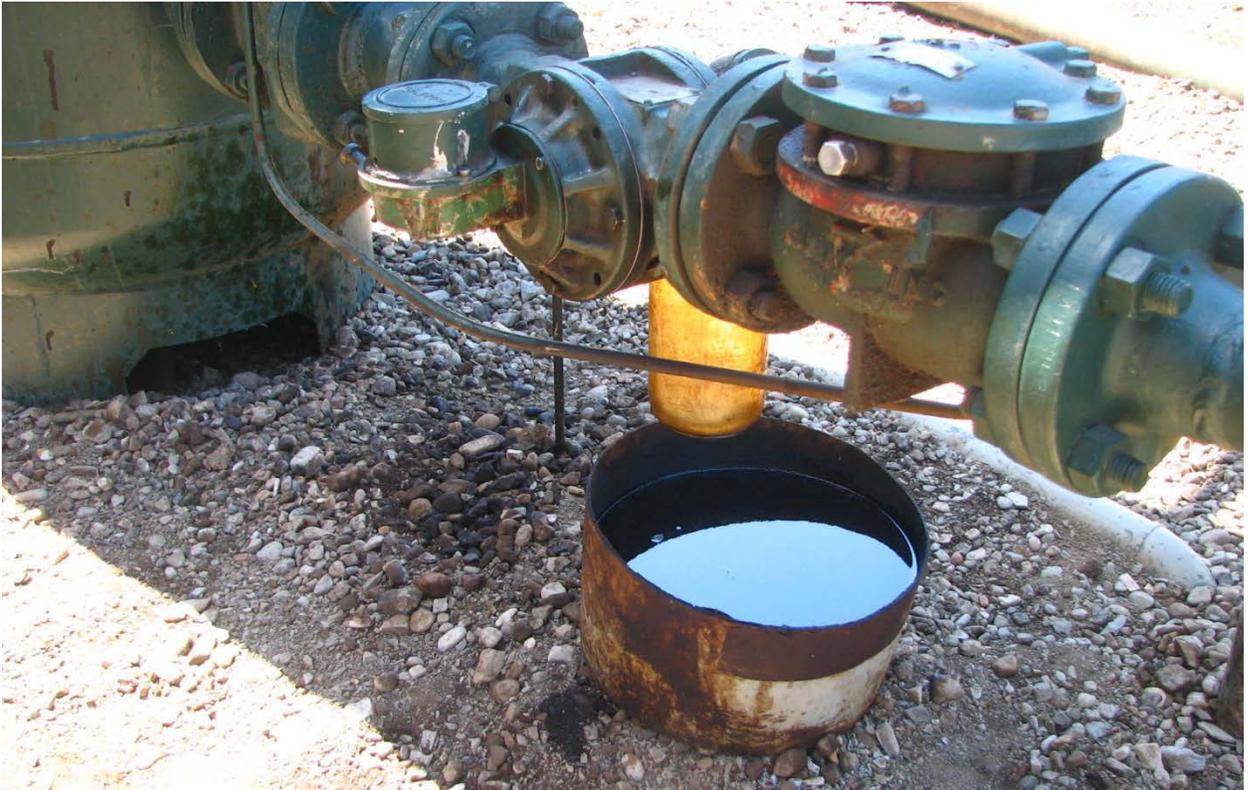
The pad contains an open container of hazardous fluid located at the base of a piece of equipment labeled "FB SLIDE PAD." This open container presents a hazard to condors and other wildlife.

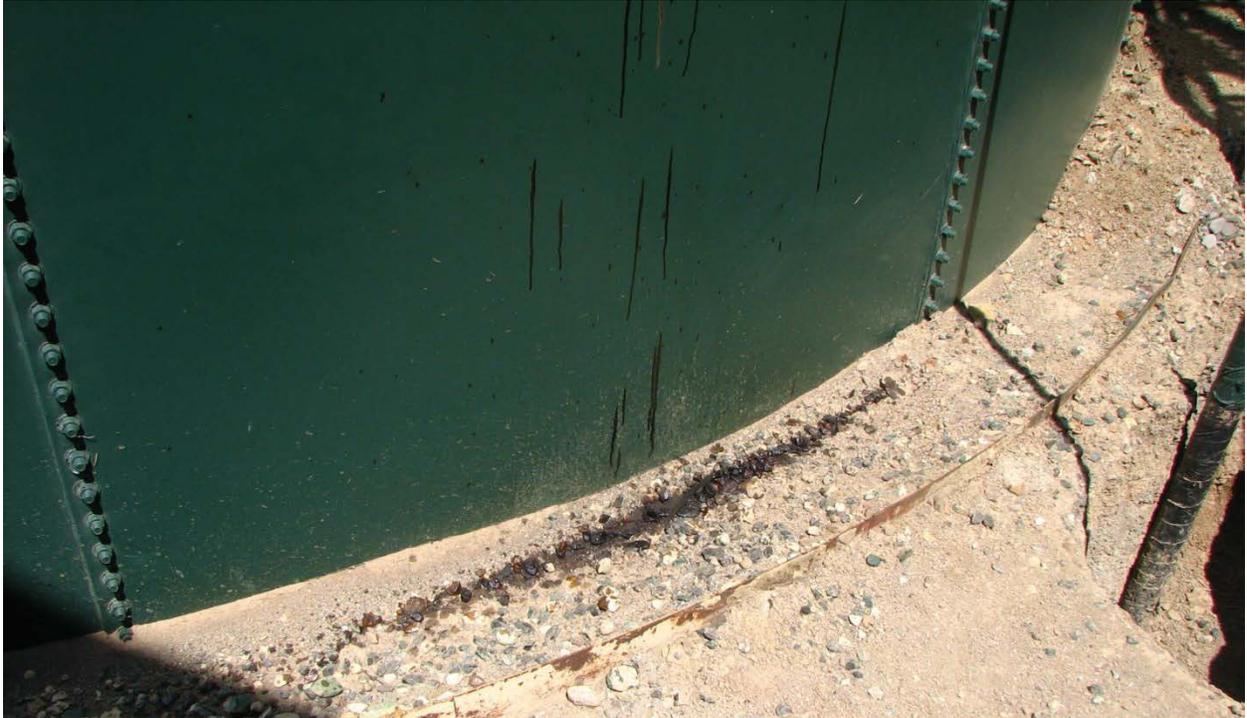
Crude Oil Tank 8 has a small oil leak, with oil accumulating at its base that could present a hazard to condors and other wildlife.

9. Repair leaking equipment and pipes and properly remediate any contaminated soil, including:
 - a. Goodman Tank Battery –oil leaking from storage tank

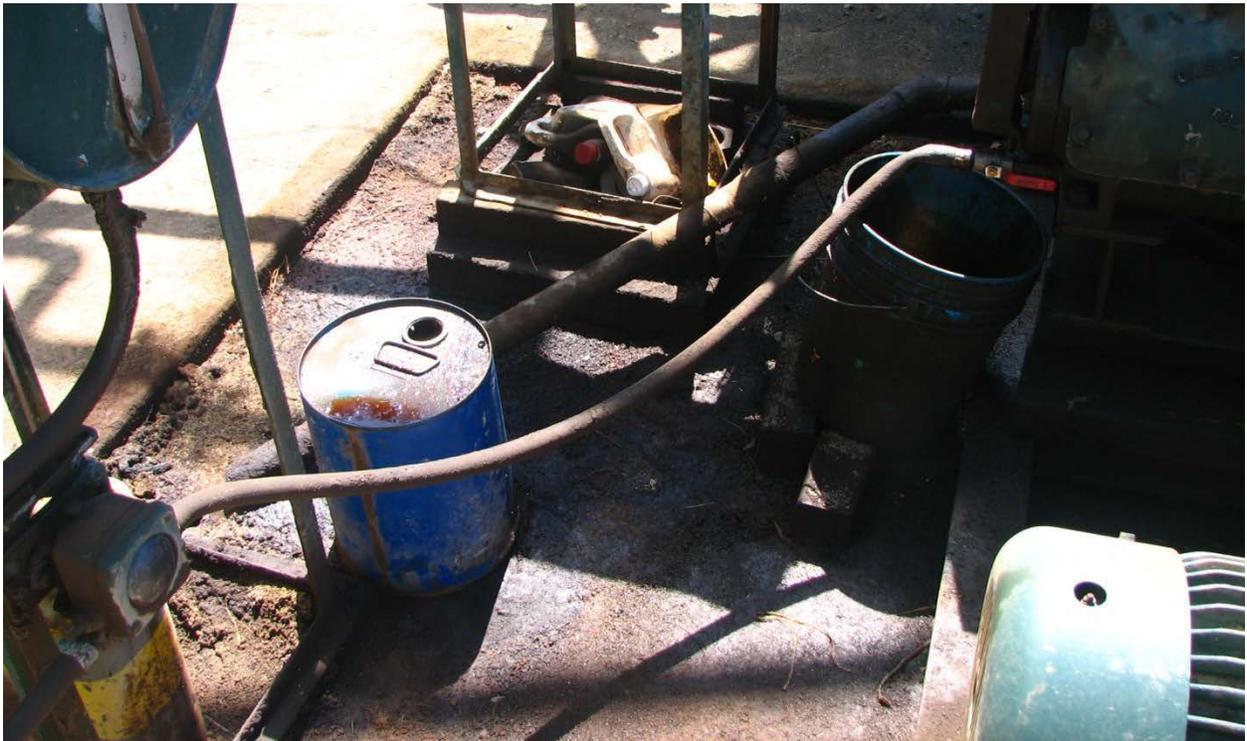
Several open containers of hazardous fluid were observed near the tank battery.

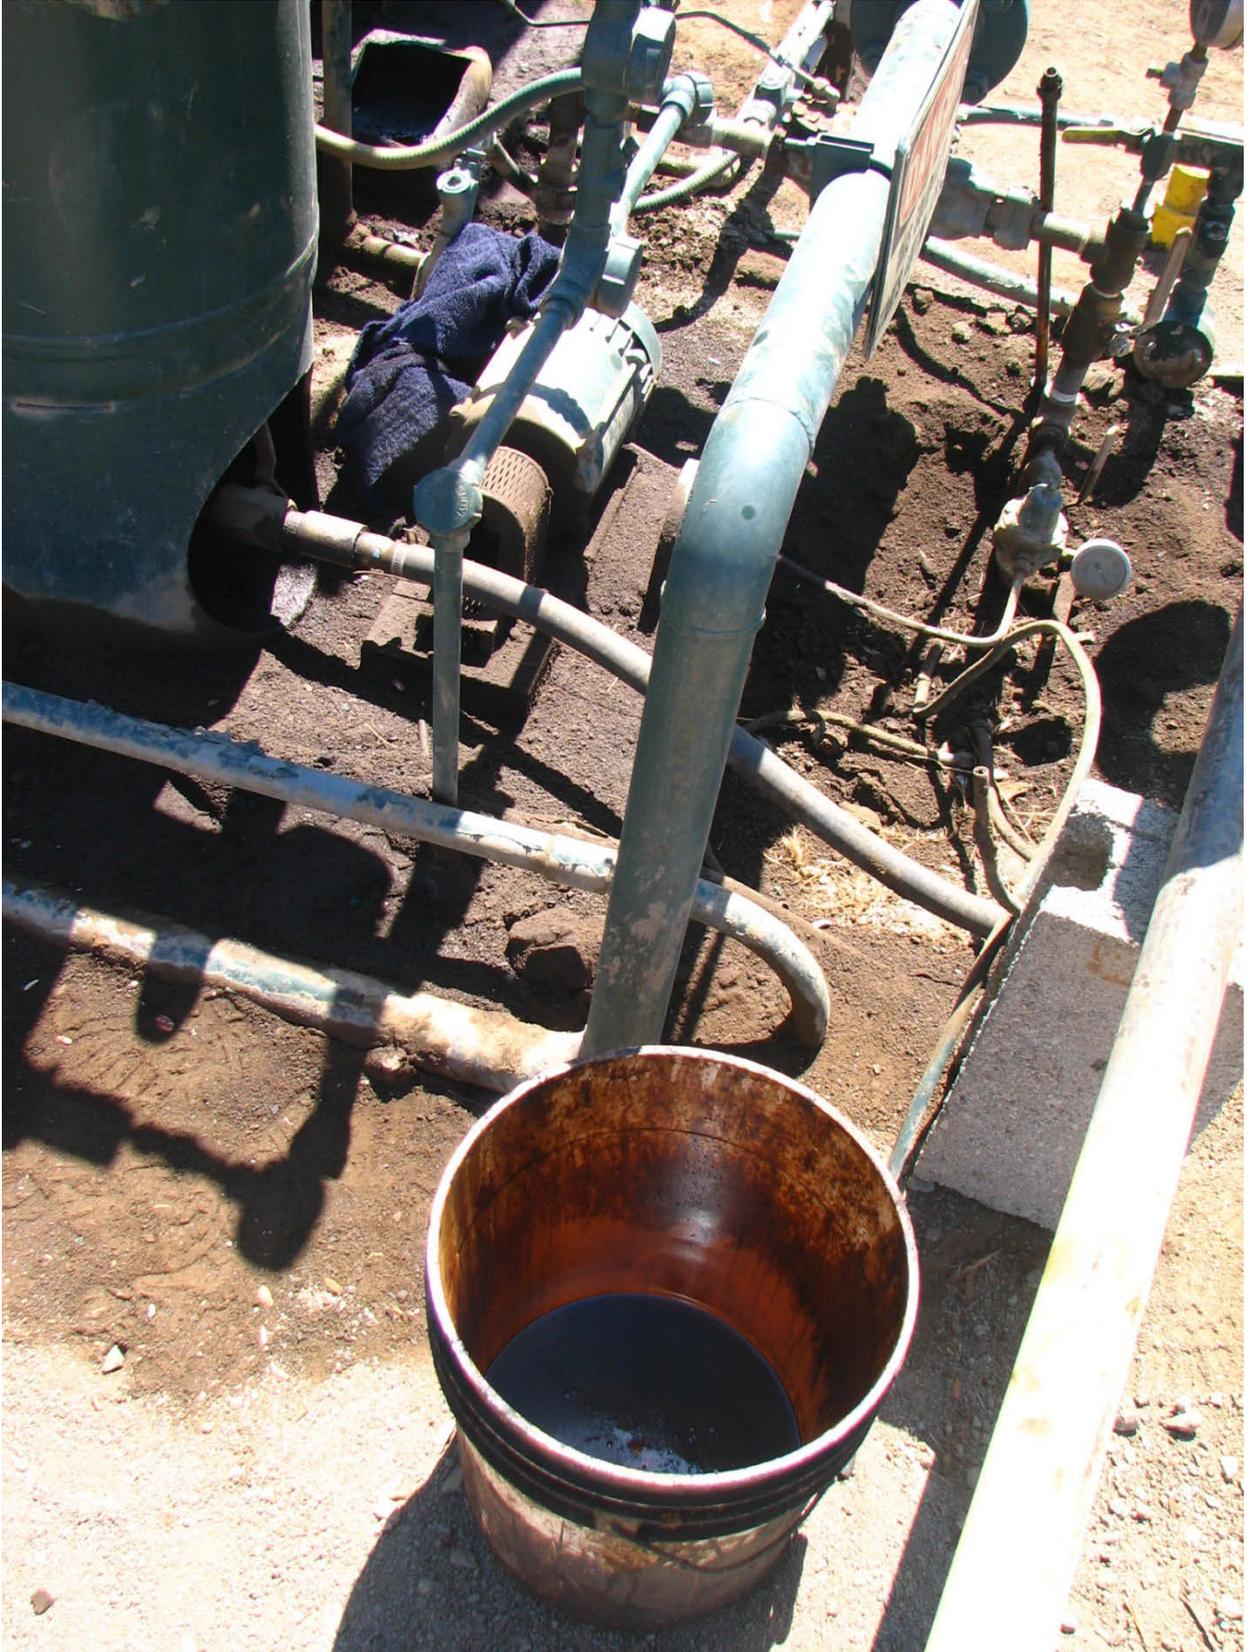
A large area of contaminated soil was observed on this pad.
