TRASHING THE SESPE

**How the Oil Industry is Littering Our
Public Lands and Endangering Wildlife**

November 2013

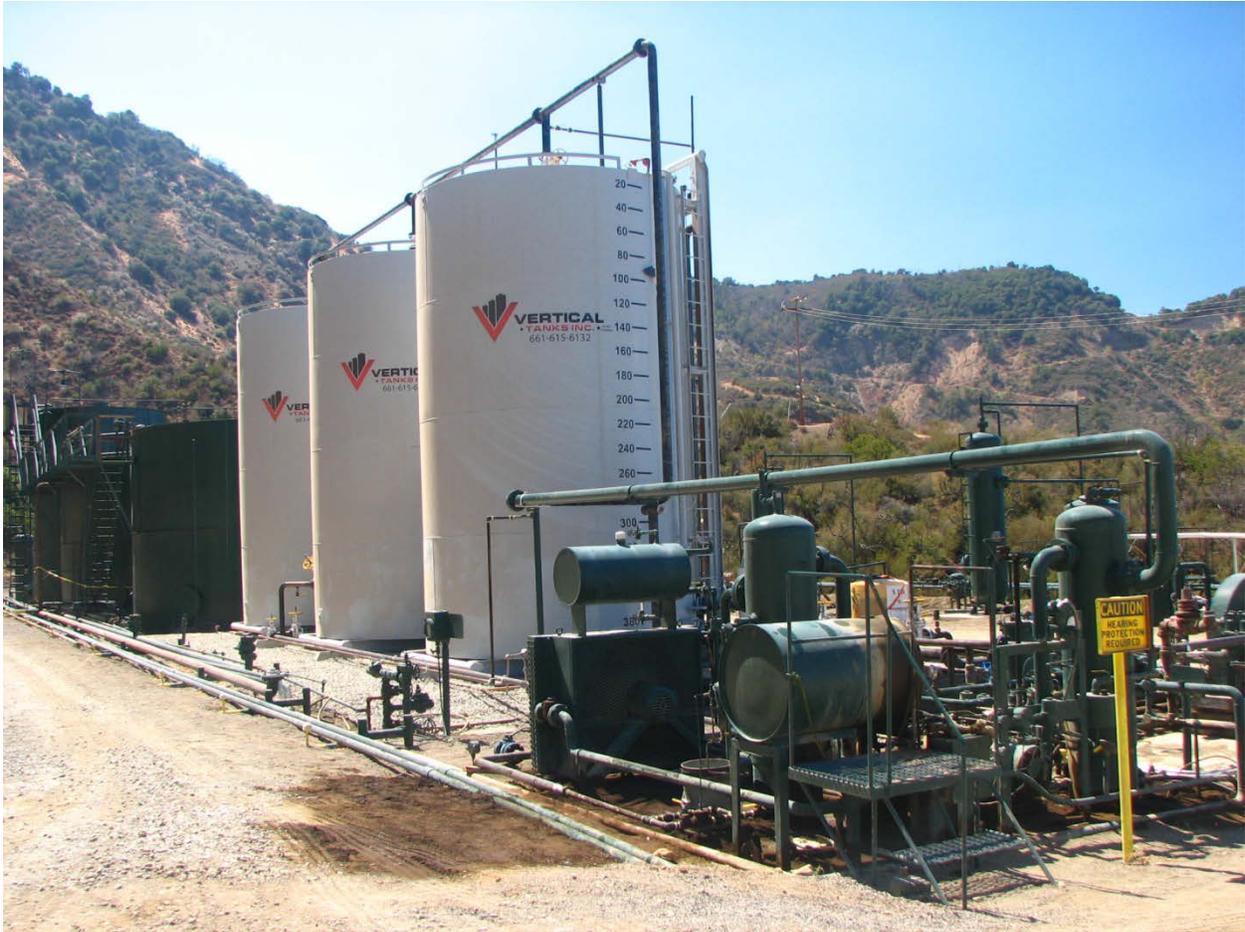
A large area of contaminated soil was observed on this pad.

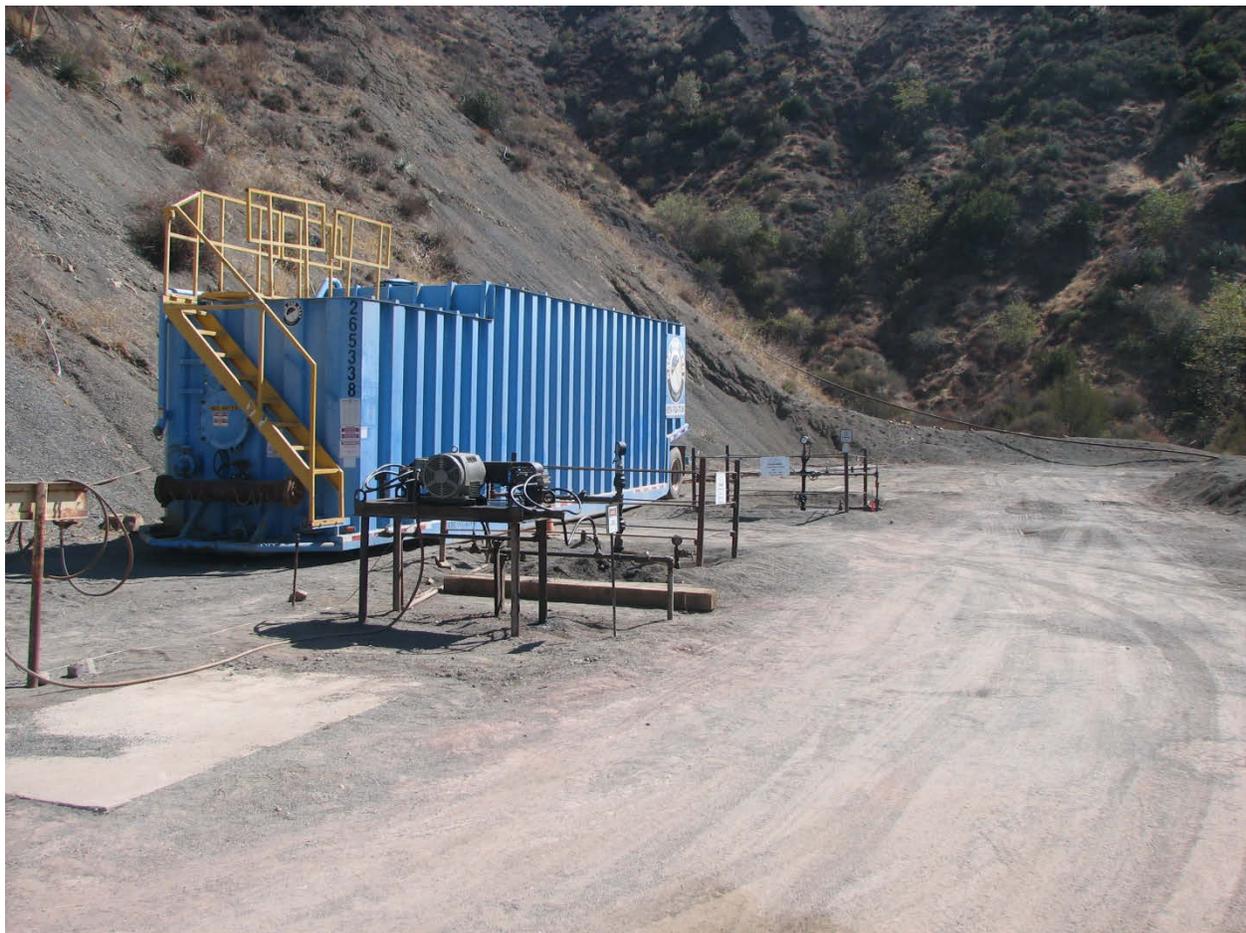
Goodman Wells 1, 3 & Produced Water Rollaway Tank

This pad includes two active wastewater disposal wells, and a rollaway tank that stores produced water (underground water that is brought to the surface as a byproduct of the oil and gas extraction process). A small piece of motorized equipment is connected to hoses and underground pipelines. On the day of our inspection, the equipment was leaking an unknown fluid, yellow in color. A puddle of the fluid had accumulated around the equipment and was leaking onto the ground.

- d. Goodman Wells 1, 3 – unknown yellow fluid leaking from equipment
 - e. Shale Ridge Well 18-28 – oil leaking from wellhead
10. Remove the following items on the wellpads to prevent hazards to condors and other wildlife:

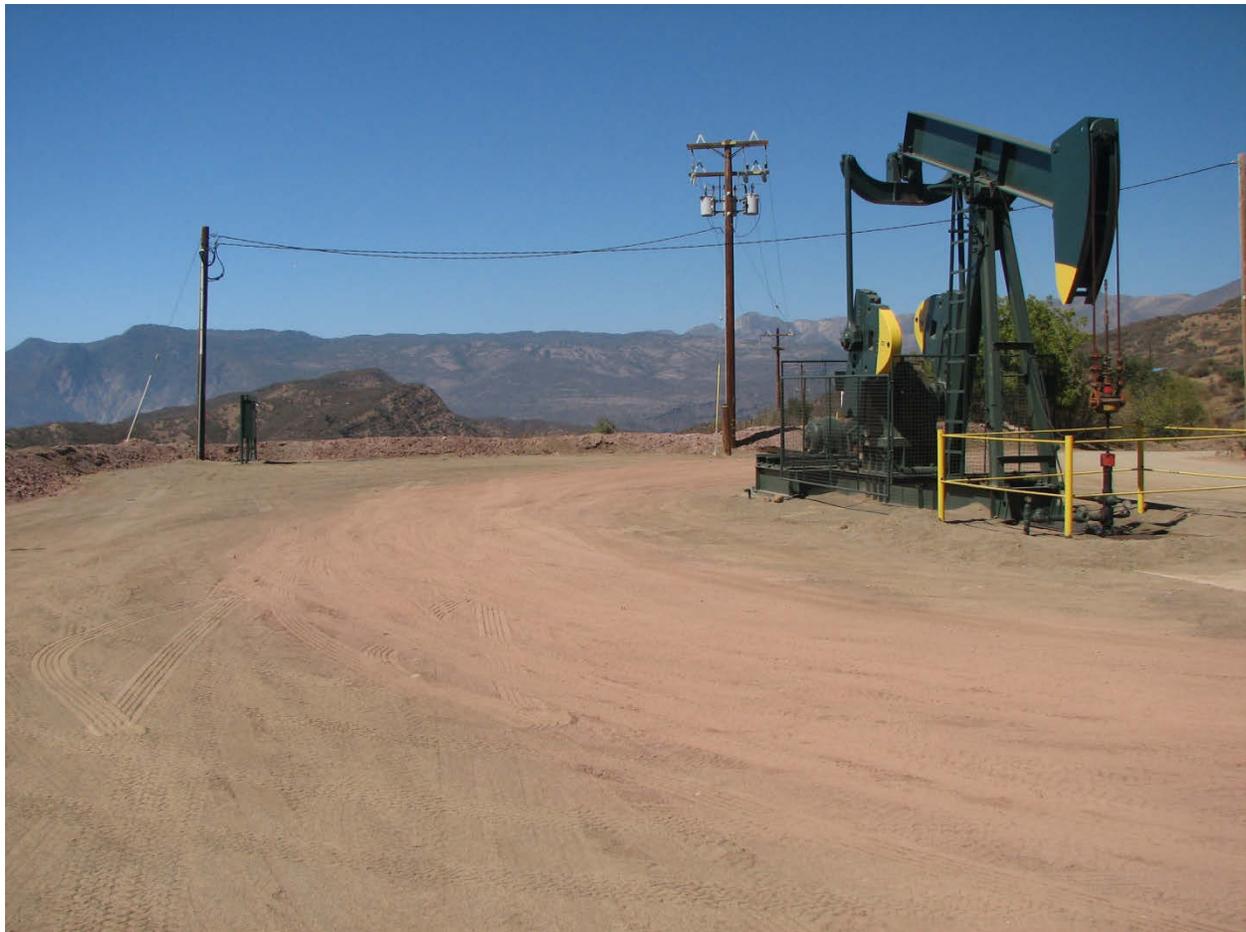
Shale Ridge 18-28

This pad contains an active oil and gas well, utility poles, a row of electrical panels, and an old abandoned dump truck.

During our visit, we observed a significant amount of oil leaking from the wellhead that could present a hazard to condors and other wildlife.

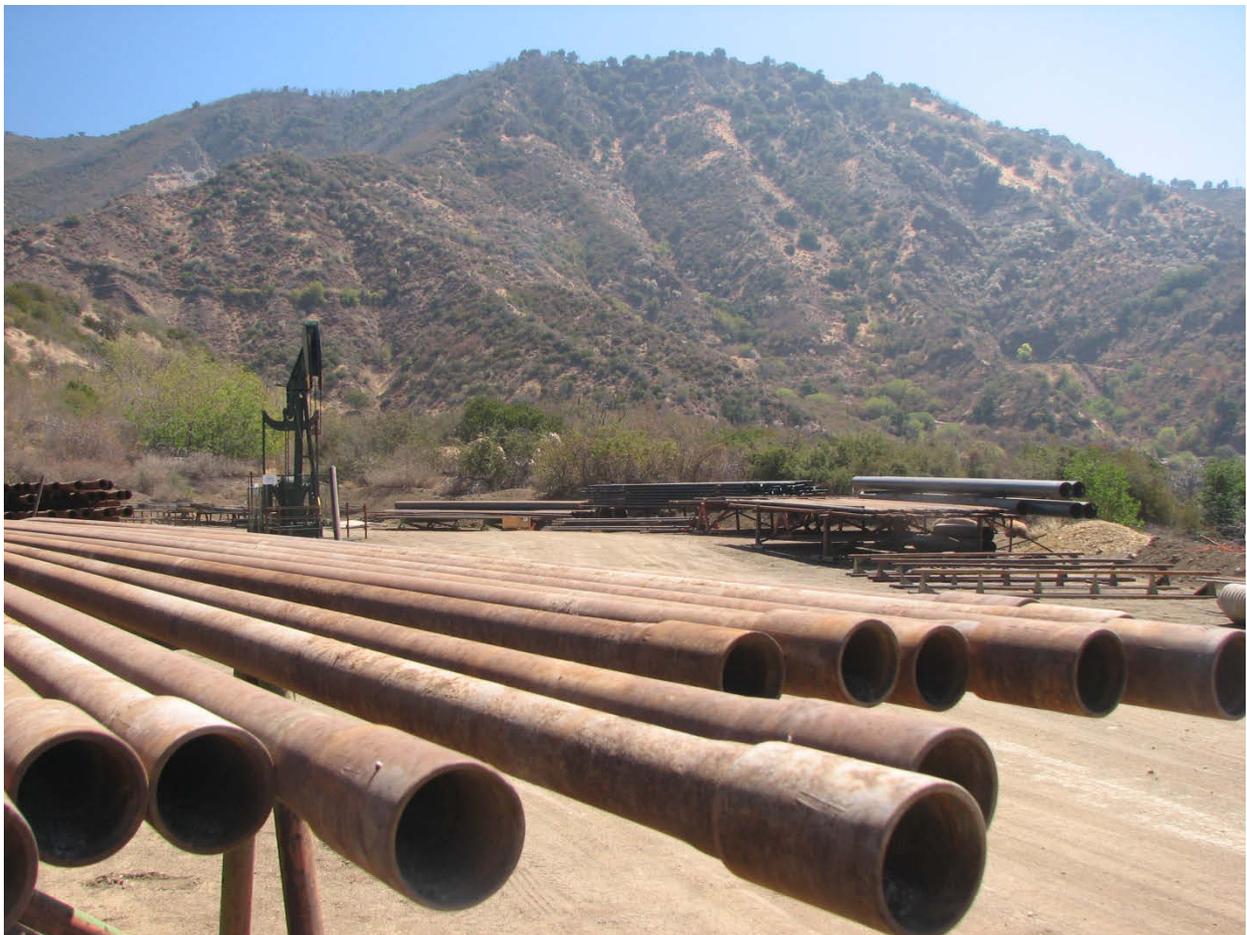
Pipeyard & Shale Ridge Well 17-28

This large pad is used to store pipes and other equipment used in the Sespe Oil Field. There is also an active oil and gas well located on the pad, along with a utility pole laying on the ground, and two covered roll-away trash bins.

We observed many strangulation hazards on this pad, including long segments of nylon rope left on the ground. We also observed larger pieces of trash, including large black plastic caps, and metal straps.

3. Properly cover all cables and hoses that present a strangulation hazard to condors.
4. Properly cover or remove open buckets of oil and other hazardous fluids.

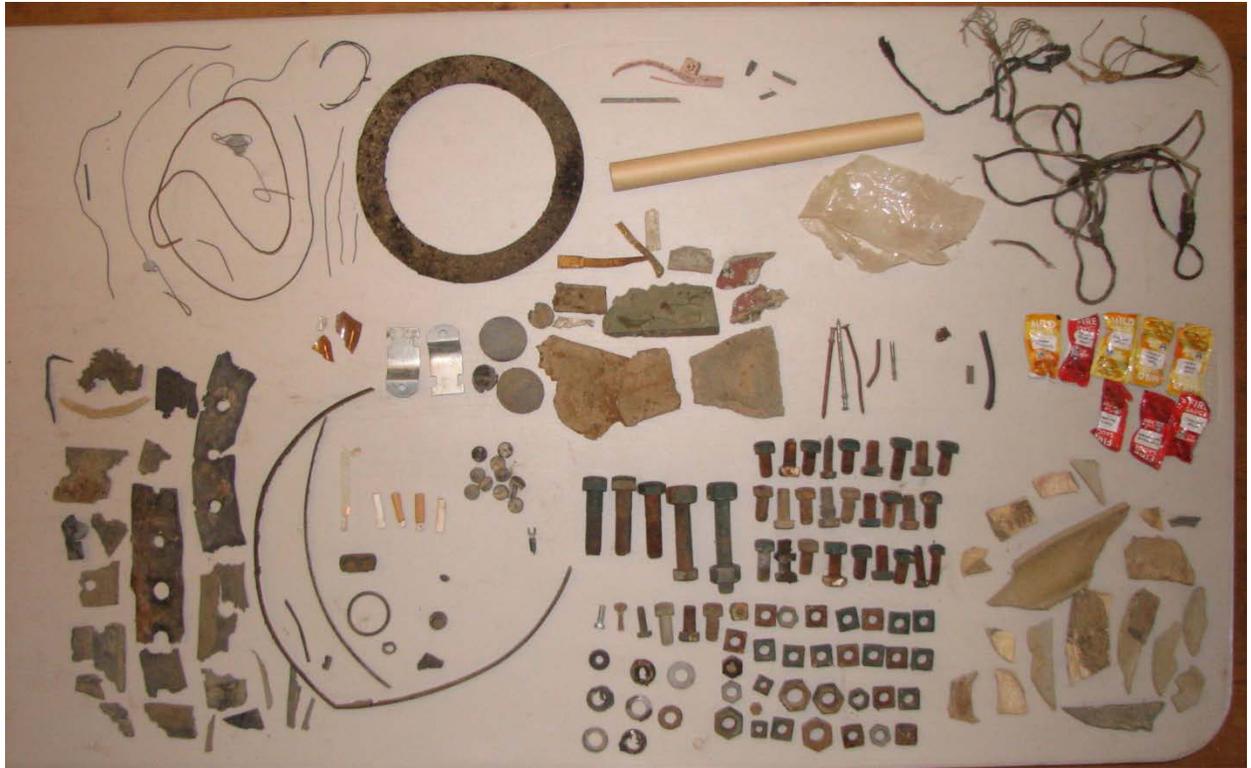
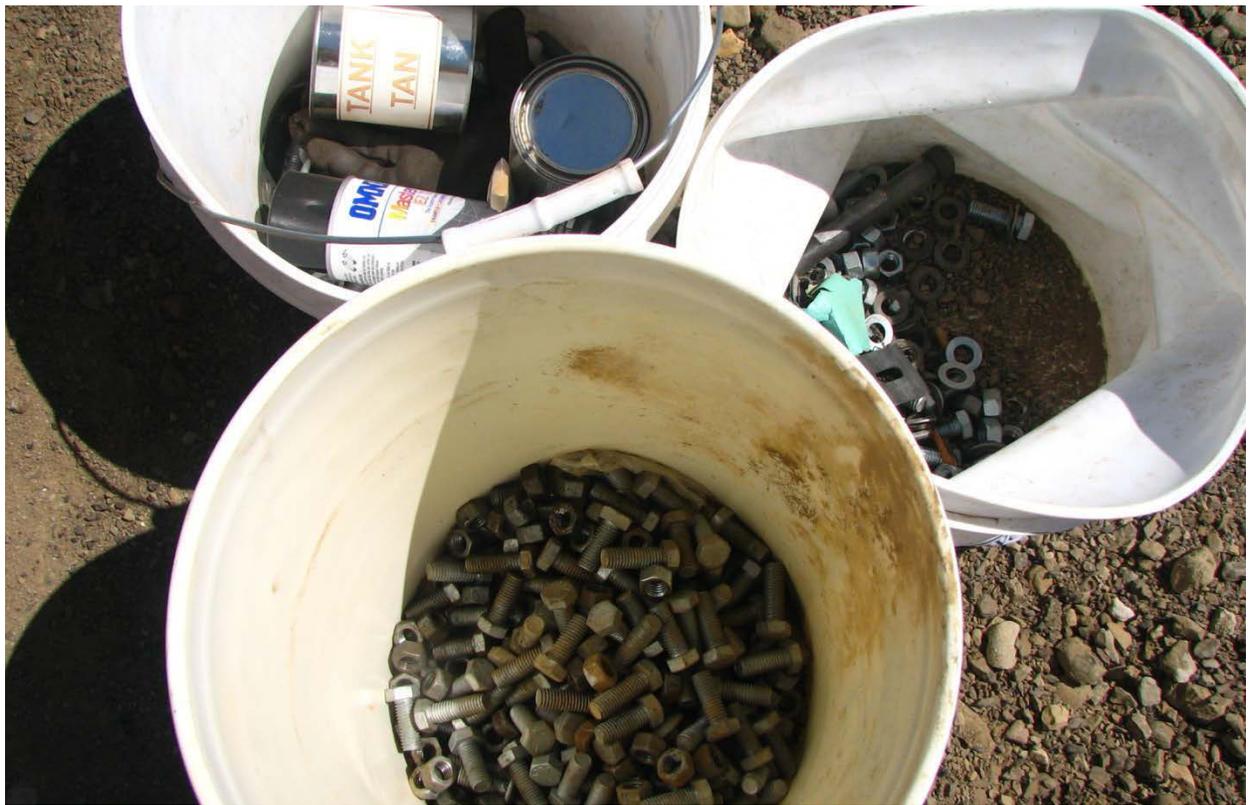
We also observed three uncovered paint buckets with nuts, bolts and washers. The lids were laying on the ground, so we placed the lids back on the containers so that condors would not be able to access the materials. A tool storage rack was also present on the pad, containing lots of microtrash including cigarette butts, nuts, bolts, screws, rags, and small metal components. The inspector did not remove any materials from this rack, not wanting to interfere with an active work site. Several unused packets of Taco Bell salsa were scattered on the ground next to this tool rack. We also observed a long coiled cable and noted that it presents a strangulation hazard to condors. Finally, we observed an oily rag next to the storage tank. The rag held lots of old nuts and bolts that were not removed by the inspector.

- e. Orcutt Central Tank Battery – remove rag containing nuts and bolts
 - f. Red Rock Well 58-29, 67, and 68 – remove empty chemical drums
11. Grant independent nonprofit organizations reasonable access to pads on private lands in the Sespe Oil Field, as well as those lands in and surrounding the Sespe Oil Field that are administered by the U.S. Fish & Wildlife Service as part of the national wildlife refuge system. Such access is necessary to ensure future compliance with these recommendations and other best management practices to protect condors and other wildlife.

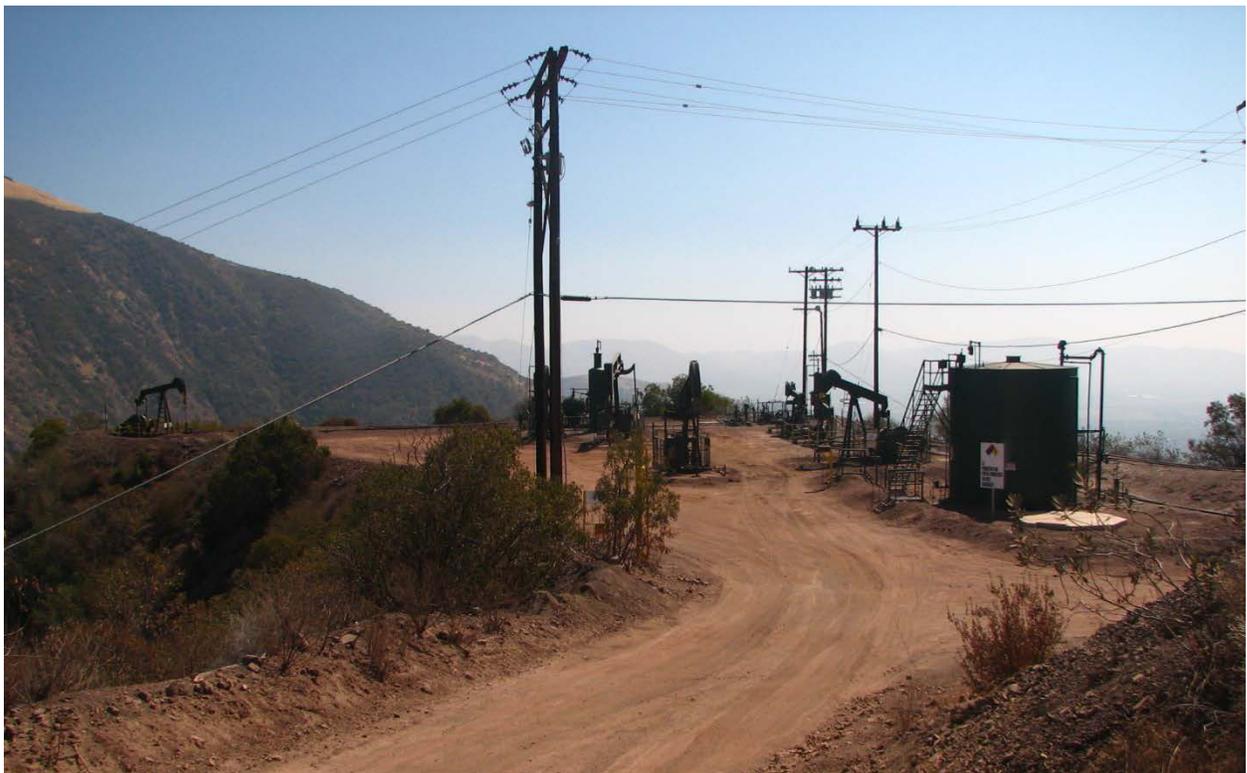
In addition to a significant amount of microtrash, we also observed an open container of crude oil and produced water at the S3 Production Tank on this pad. The container was easily accessible to condors and other wildlife. The inspector also noted some coiled cables at the base of one of the utility poles – those cables pose a strangulation hazard to condors.
