**Channel Islands Restoration
Los Padres ForestWatch
Santa Barbara Audubon Society
Santa Barbara Channelkeeper
Santa Barbara County Action Network
Urban Creeks Council**

June 16, 2023

RE: Montecito Emergency Debris Flow Mitigation Project

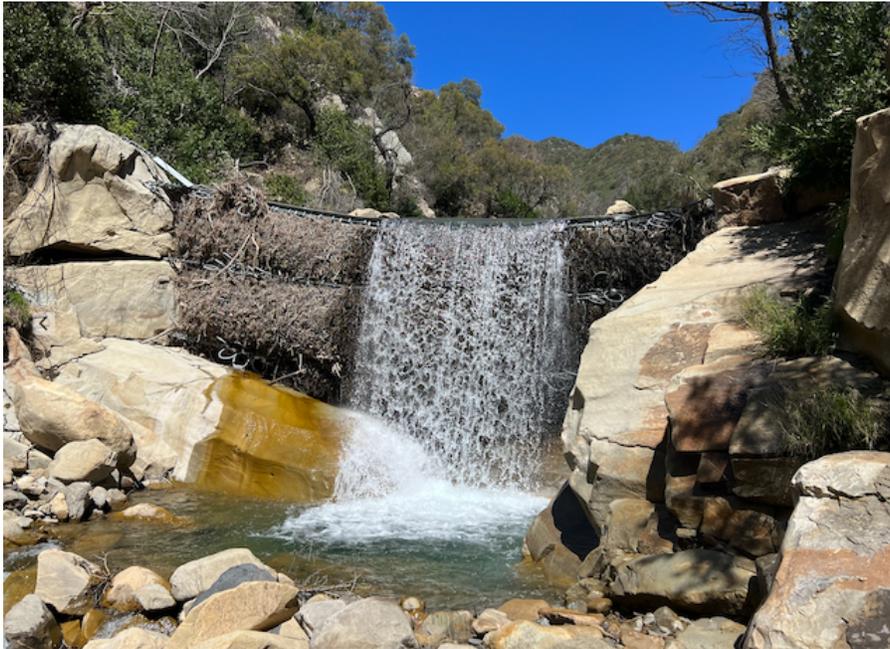
In January 2023, the net on upper San Ysidro Creek filled up with debris after the first major storm of the season. From all appearances, the net filled, *not* with the SUV-sized boulders the community was concerned about, but with smaller vegetation that backed up against the ring nets and then trapped thousands of cubic yards of cobble, gravel and sand that would have otherwise been transported to downstream beaches.

The structure currently serves as a 25-foot dam entirely blocking the creek, fragmenting sensitive wildlife habitat and posing a serious public safety hazard and liability. As of the writing of this letter, no maintenance has been performed nearly 6 months after the stream channel was originally blocked.

Figure 1: Upper San Ysidro Creek ring net plugged with vegetation and debris - April 1, 2023

As the creek remains blocked heading into the summer season, our organizations call upon local officials to re-examine the long-term future of the ring net program. Current circumstances demonstrate that the nets are not feasible to maintain. Public funds, better utilized for other purposes, are now being relied upon to implement the project. It remains unclear when and how San Ysidro Creek will be restored to pre-storm conditions. It's unclear what real amount of risk the nets mitigate for downstream neighborhoods or to what degree the nets may increase risk to downstream community members by providing a false sense of security. The mountains are now largely revegetated, and the risk of future catastrophic debris flows is very significantly reduced.

The Ring Net Project was described as experimental by project proponents and always considered temporary by permitting resource agencies. We find that its purpose has now been served. It's time to restore our creeks and take down the ring nets.

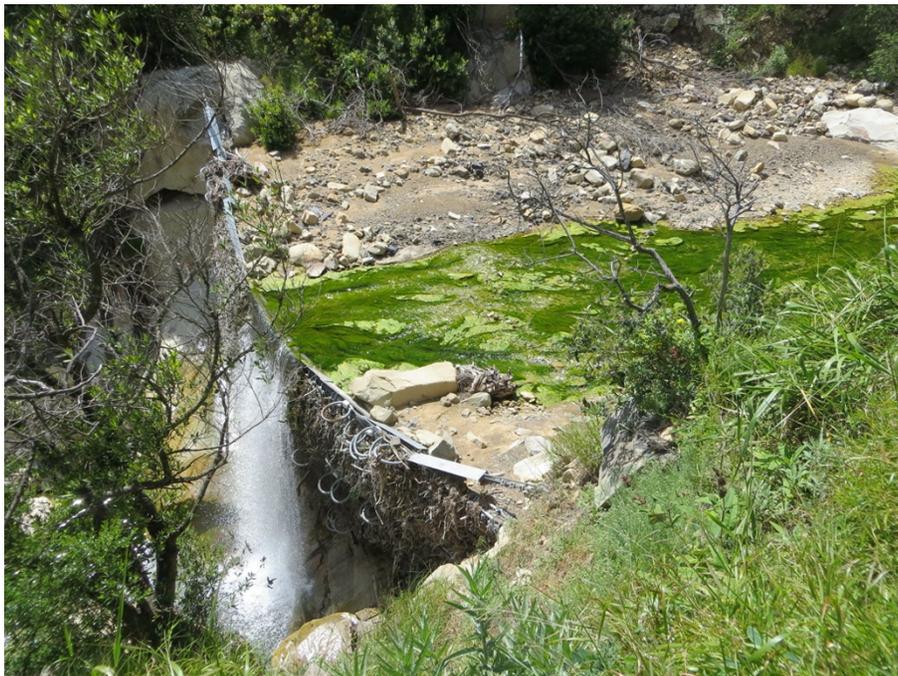
Figure 2: Upstream view of Upper San Ysidro Creek ring net - May 12, 2023
